RESEARCH AND INVESTIGATION INTO THE PERFORMANCE OF RAIN WATER TANKS IN BUSHFIRES

A recent research project involving the Bushfire Cooperative Research Centre (Bushfire CRC) and the CSIRO has revealed that different types of rainwater tanks can play an important role in defending houses against the threat of a bushfire.

The research project was conducted in the NSW Rural Fire Service experimental research facility at Mogo on the south coast of NSW.

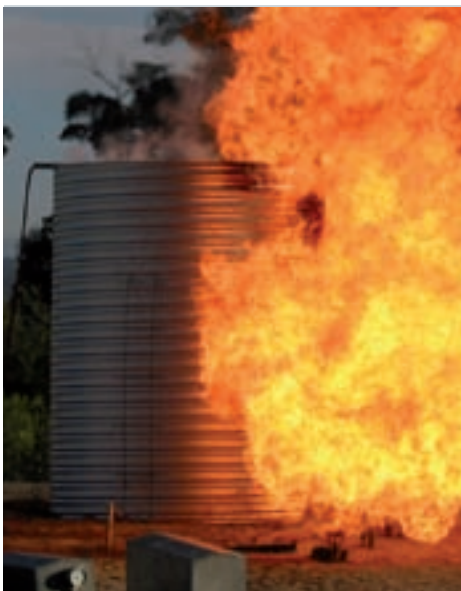
LEFT: WATERPOINT® CLASSIC DURING TESTING AND ABOVE RIGHT: STEEL CONSTRUCTION TANK AFTER FIRE FRONT

Of the different materials tested, spiral wound, steel tanks performed best under all exposure conditions. All steel manufactured tanks maintained structural integrity when faced with a 30-minute flame immersion test, simulating an adjacent structural fire (see table overleaf for further details on exposure levels).

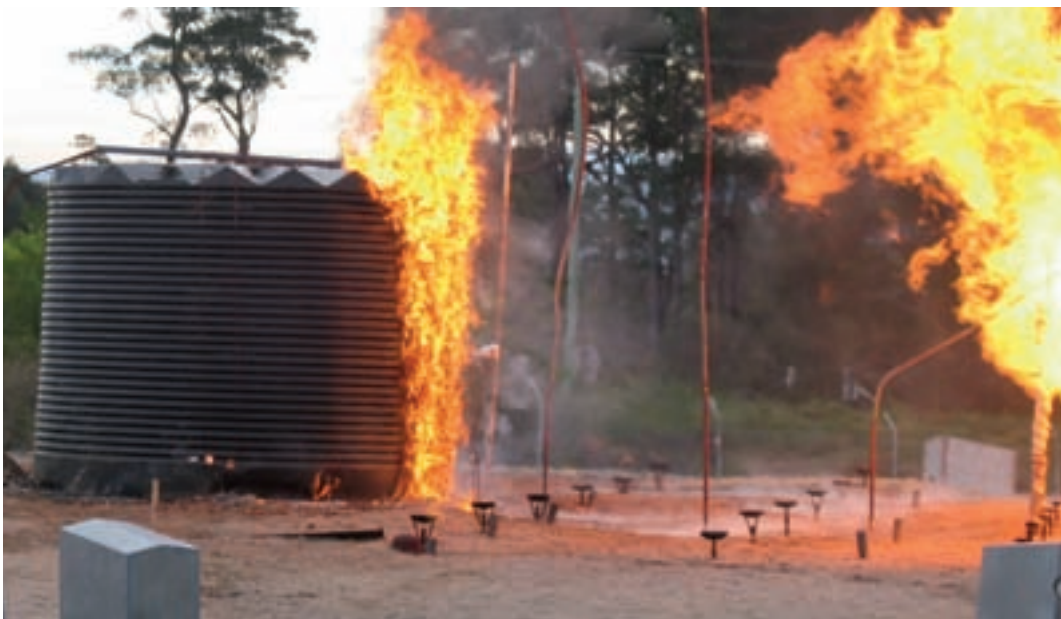
RIGHT: PIONEER GALAXY TANK DURING TESTING

Steel construction liner tanks maintained structural integrity during all tests. The liner construction proved able to retain water during and after the fire-front, which is critical for the protection of property and assets in the event of a bushfire.
